TEST REPORT

REPORT REF: TR5018/218238 **SAMPLE RECEIVED:** 01 October 2018
REPORT ISSUED: 17 October 2018

SAMPLE DESCRIPTION: Entrance Matting – Romus Quick Mat
Vendor / Manufacturer: Romus
Item No. Scrapex

Wheeled Traffic Trolley Test conducted on behalf of Romus

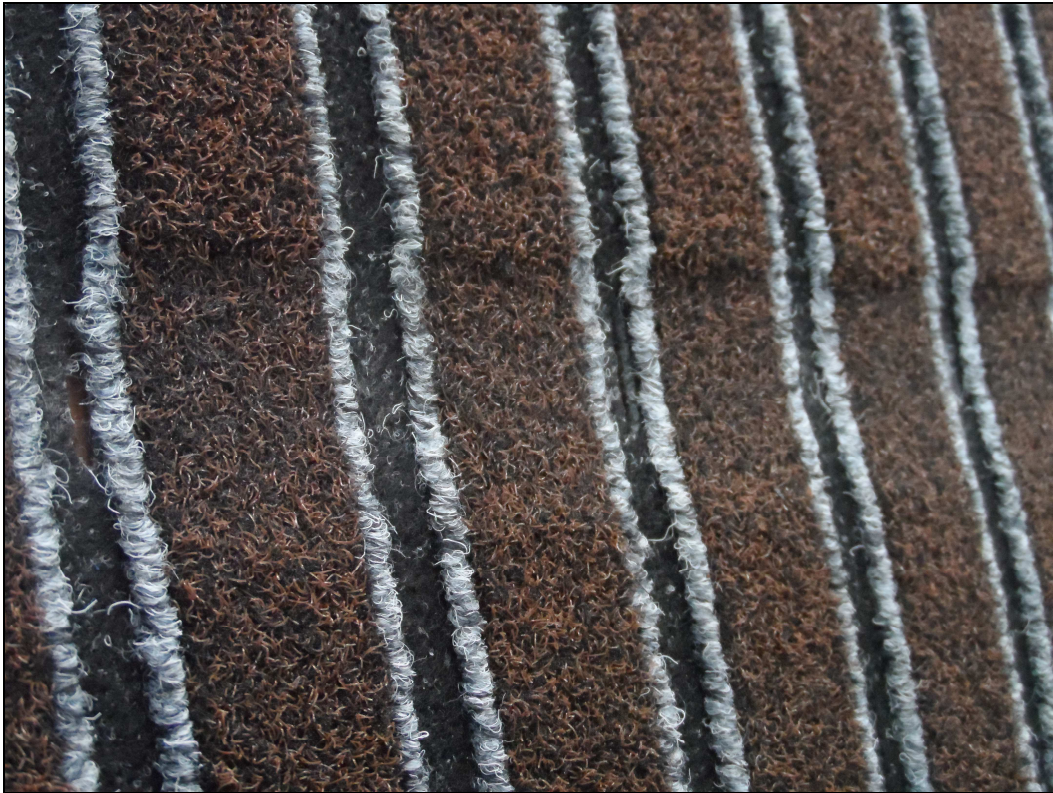
Figure 1

After 15,000 cycles, or 30,000 passes, the mat was inspected and it was noted that there was some compression of the pile. There was no structural damage to the mat.

After 50,000 cycles or 100,000 passes, the mat was inspected and it was noted that there was some further compression of the pile. There was no structural damage to the mat. See figure 1 below.
